Case 1. Ulterra motor does not turn on when the Power button on the control panel is pressed and released. The green “System Ready” and red “Status” LEDs do not light up.

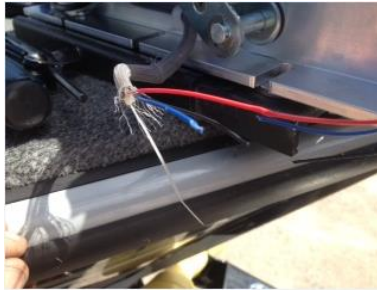
Possible Cause 2: This malfunction is often found to be a result of unintentional/accidental damage to one or more of the three wires that connect each of the three Hall Effect Ulterra motor sensors to the main control board. The red, blue, and black wires going to each sensor are enclosed in black or gray mesh tubing running along both sides of the motor base extrusion. These wires can be accidentally damaged, pinched, or cut if care is not used to make certain that the motor (or Quick Release Plate)

mounting bolts do not damage the wires when the bolts are tightened. The cutting of any of the sensor wires will cause the motor to be inoperative.

Figure 1: Actual photo supplied by a service provider.

Corrective Action: Contact your local Minn Kota service provider for an evaluation.
